Kalama, Washougal and Lewis River Habitat Assessments

Chapter 5: The Salmon Creek Basin

R2 Resource Consultants, Inc.

December 2004

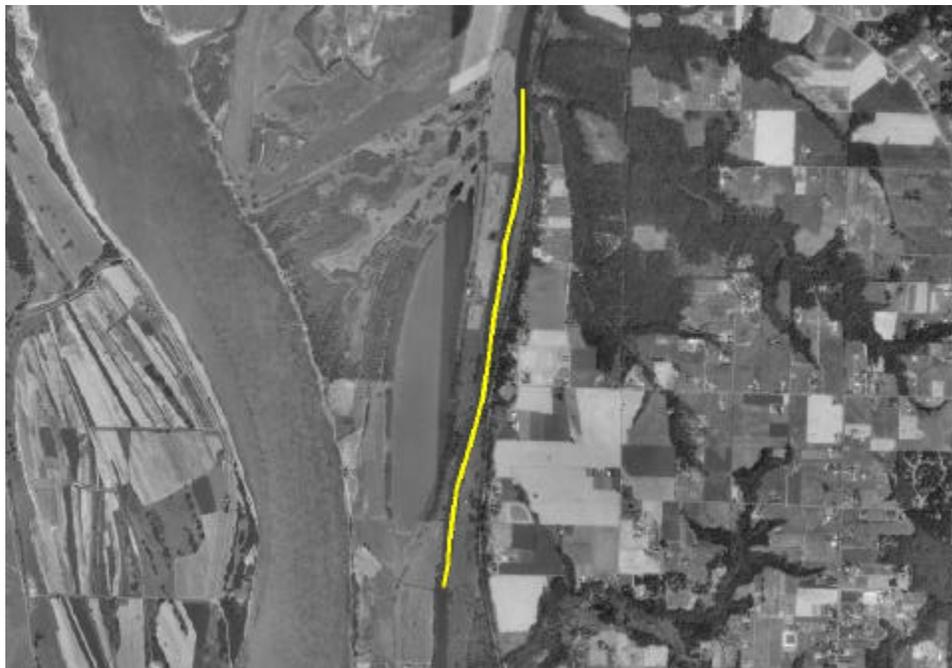
Map B-1. Portion of Lake River 2 surveyed.

Lake River is a former side channel of the Columbia River. As such it has a very low gradient and is located wholly within the Columbia River floodplain. Lake River currently receives inflow from the Columbia River as well as Salmon Creek and several smaller tributaries. However, given the low gradient and extensive floodplain it likely has a lower stream power than other mainstem river segments. The entire length of Lake River 2 was surveyed as highlighted in yellow in Map B-1.

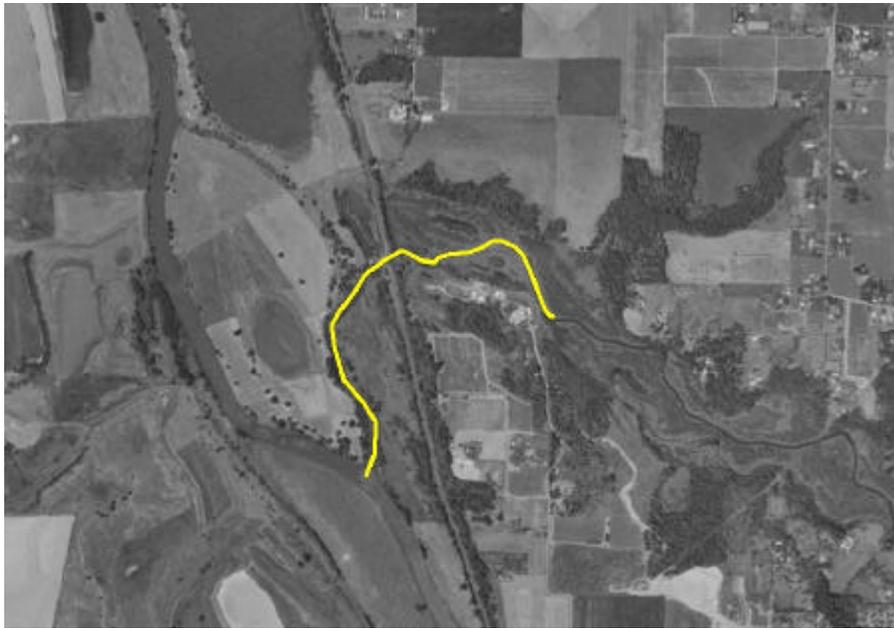
Map B-2. Portion of Salmon 1-4 surveyed.

Salmon Creek is a tributary of the Columbia River that flows into Lake River, a side channel of the Columbia River. The lower 16 miles of Salmon Creek flow through an approximately 450 m (1,500 ft) wide valley that is carved through extensive Lake Missoula flood deposits. The channel gradient is very low, and the channel meanders back and forth across the valley bottom. Topographic maps reveal numerous sloughs in the lower 4 miles of river. Several ponds that may represent former gravel extraction operations are present near RM 6.0. Reaches 1 - 4 are short channel segments located in the first 1-mile of Salmon Creek that exhibit the same general morphology and habitat conditions. These reaches were surveyed and analyzed as a single unit. The lower section of these reaches, downstream of the railroad bridge, flows across the current Columbia River floodplain. The entire length of Salmon 1 - 4 was surveyed as highlighted in yellow in Map B-2.

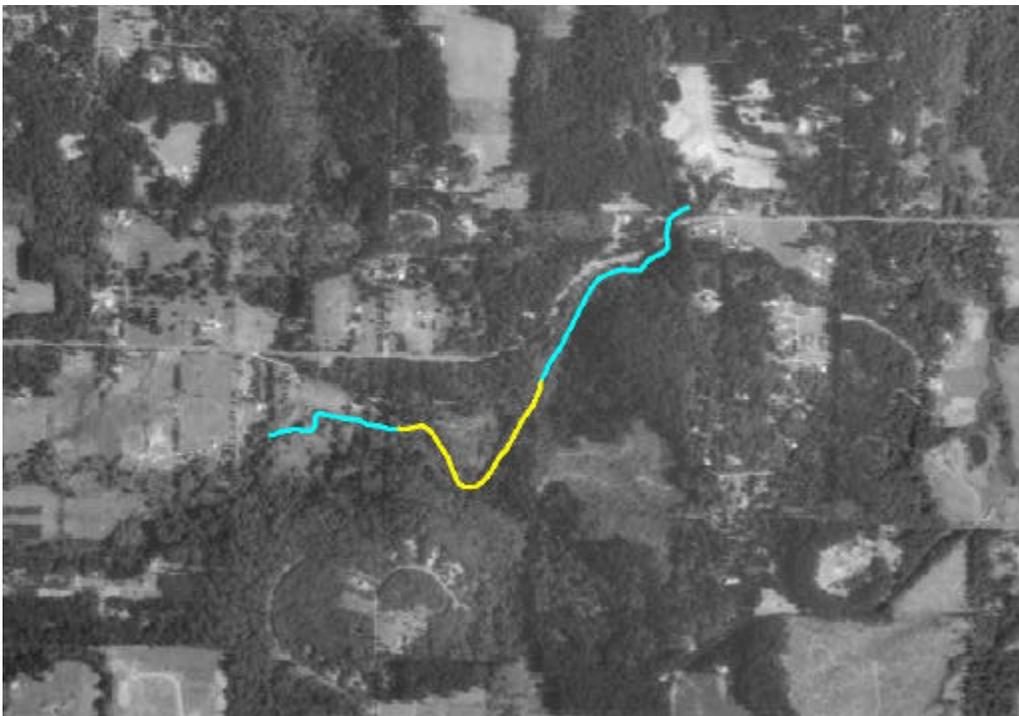
Map B-3. Portion of Salmon 27 surveyed.

Salmon Creek Reach 27 is located in the upstream part of the Salmon Creek basin. Salmon 27 is a 2.0-mile long reach beginning at the Rock Creek confluence. At the confluence with Rock Creek, Salmon Creek occupies a narrow gorge. The downstream end of Salmon 27 flows into a wide valley. The survey segment was located in the less confined portion of Salmon 27, and thus, it may not be representative of the reach as a whole (Map B-3).

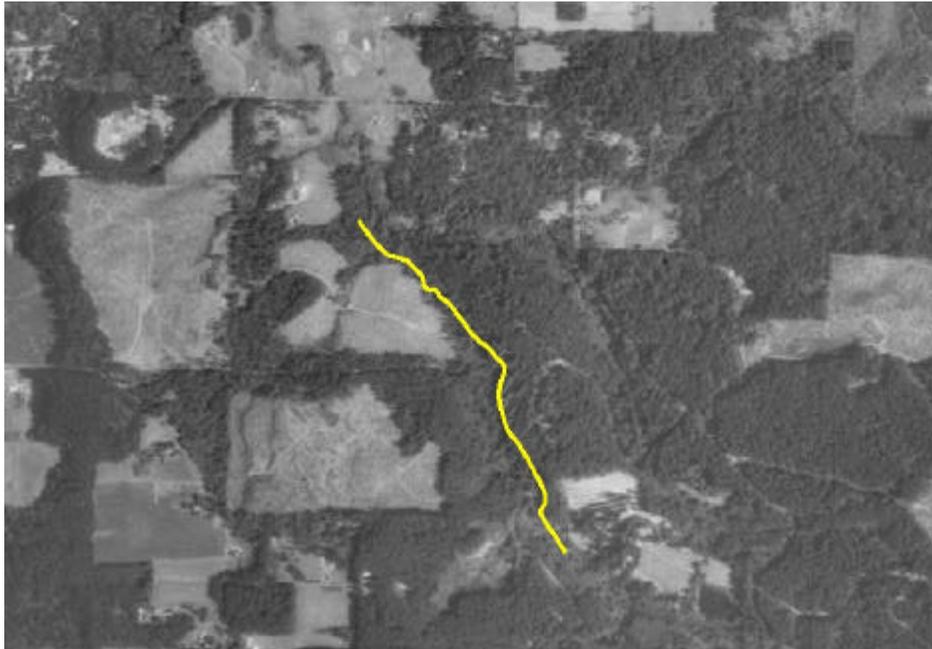
Map B-4. Portion of Salmon 32 surveyed.

Salmon Creek Reach 32 is located in the upper Salmon Creek basin and it is the most upstream reach of the river accessible to anadromous fishes. Salmon 32 is a 2.5 mile long reach that ends at Salmon Falls. For most of its length, Salmon 32 occupies a narrow v-shaped valley. The downstream end of Salmon 32 flows into a wide valley. The entire segment was surveyed (Map B-4).

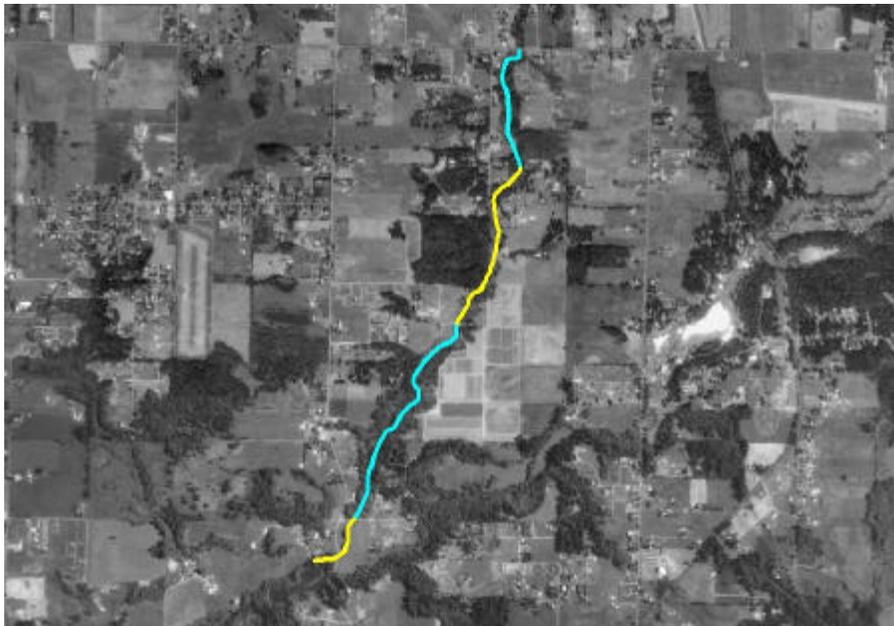
Map B-5. Portion of Weaver 1 surveyed.

Weaver Creek 1 is a tributary to Salmon Creek that enters from the north at RM 14.6. Reach 1 of Weaver Creek extends from its confluence with Salmon Creek to the culvert where NE 199th Street crosses the stream. For most of the 2 mile section of Reach 1, Weaver Creek flows through a narrow v-shaped valley. The lowermost 305m (1,000 feet) of Weaver 1 flows across a small alluvial fan formed where Weaver Creek enters the Salmon Creek Valley. A total length of 1.1 km (0.7 mile) in two segments of this reach was surveyed as highlighted in yellow in Map B-5.

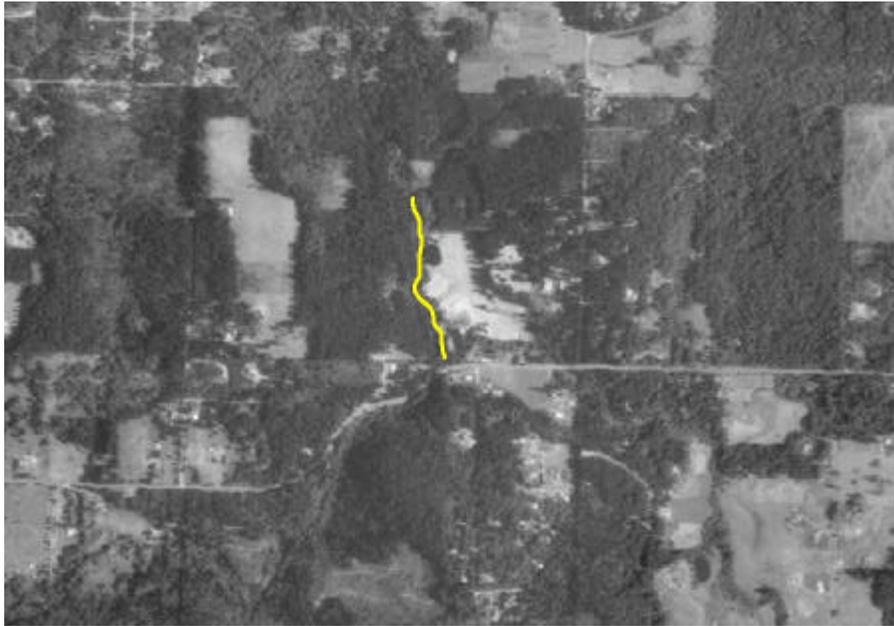
Map B-6. Portion of Rock 1 surveyed.

Rock Creek is a tributary to Salmon Creek that enters from the north near RM 22. Reach 1 of Rock Creek extends from the confluence with Salmon Creek to a left bank tributary that enters near RM 0.3. Rock 1 occupies a narrow v-shaped valley. The entire reach was surveyed in 2004 (Map B-6).

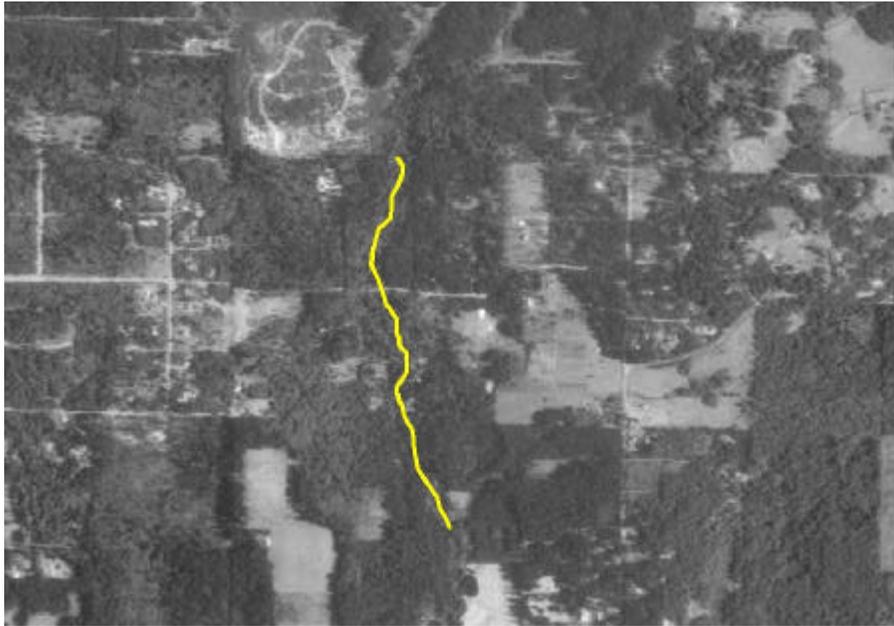
Map B-7. Portion of Rock 2 surveyed.

Rock Creek is a tributary to Salmon Creek that enters from the north near RM 22. Reach 2 of Rock Creek extends from RM 0.3 to RM 1.1. Rock 2 occupies a narrow v-shaped valley, although there are some wider areas than were present in Rock 1. The entire reach was surveyed in 2004 (Map B-7).
